## RESIDENTIAL INSPECTION

2871 Brant St  
San Diego, CA 92103

08/28/2026

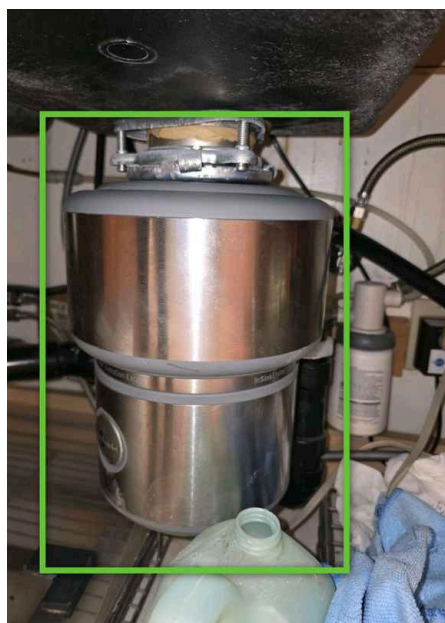
#### Garbage Disposal: Garbage disposal condition

Garbage disposal was functional at time of inspection.

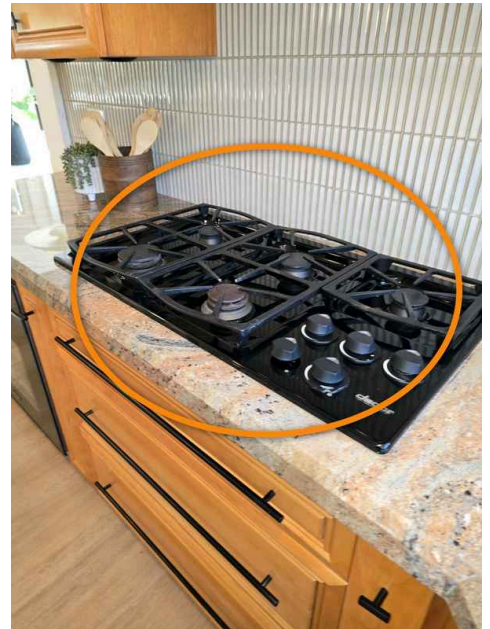
**BURNER(S) INOPERABLE**

One or more of the burner(s) did not operate when tested. Observed one or more burner(s) not igniting to flame when tested at the burner controls. Refer to the sellers and sellers disclosures to advise. Seek a qualified appliance contractor for further evaluations and repairs or replacement. Note: this condition is typically grease/debris buildup that is blocking the gas flow to the igniter and it might be in need of cleaning.

Contact a qualified professional.

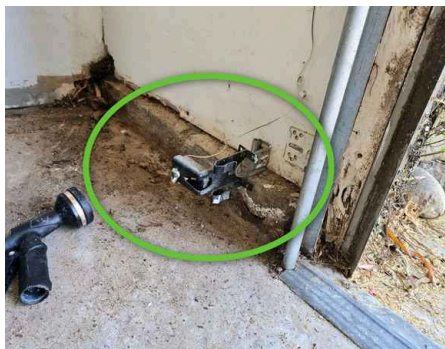
### Door's Reverse Status: Eye beam sensor

Eye beam system present and operating at time of inspection.

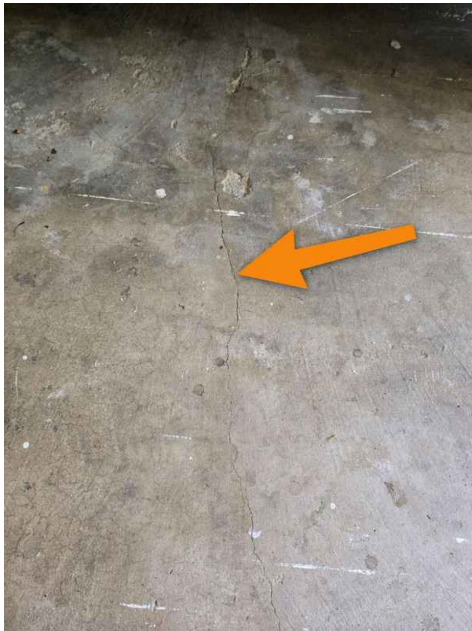
#### FLOOR CRACK(S)

Typical Settlement cracks noted at the garage floor in one or more location. This can be an indication of possible structural settlement/movement in the home. Advise further evaluated by a licensed foundation contractor and monitor or repair as necessary.

Contact a foundation contractor.

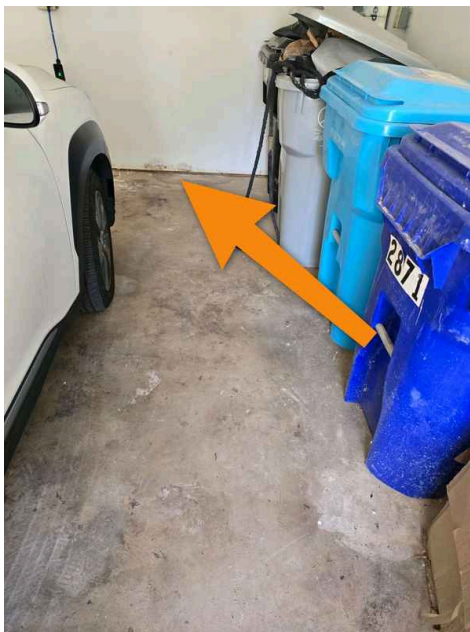
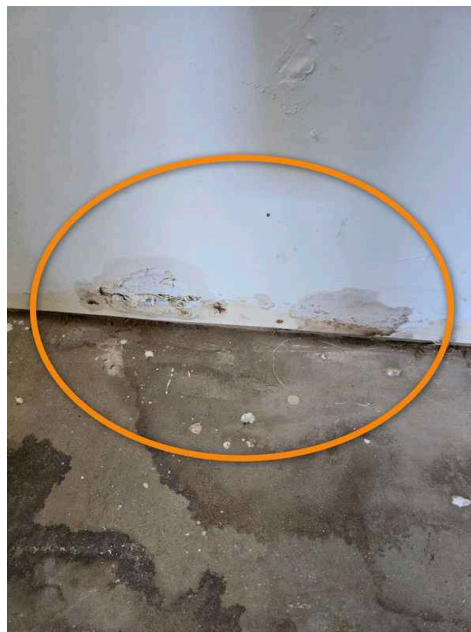
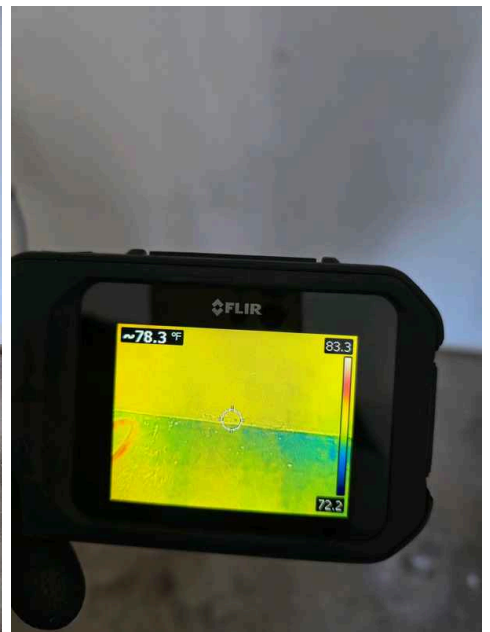
#### **WATER STAINING**

What appears to be water/moisture stains was noted at one or more locations. Conditions tested dry at time of inspection when scanned with the thermal camera and moisture meter. Refer to the sellers and sellers disclosures to advise. Seek a licensed contractor for further evaluations and any necessary repairs if needed.

Contact a qualified professional.

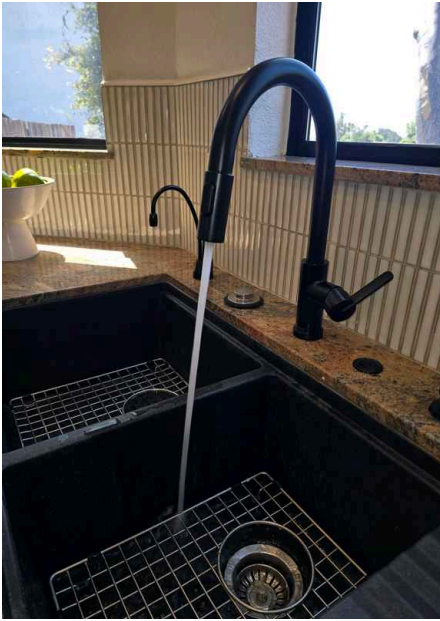
**Sinks: Sinks condition**

The sinks and its components were functional.

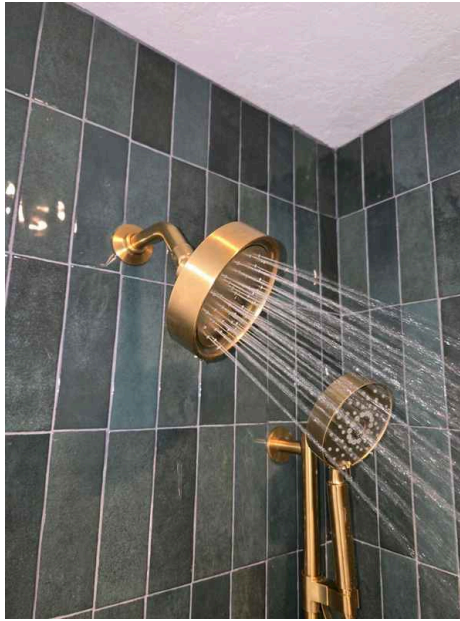
**Showers: Showers operational**

The bathroom showers are functional at time of inspection.

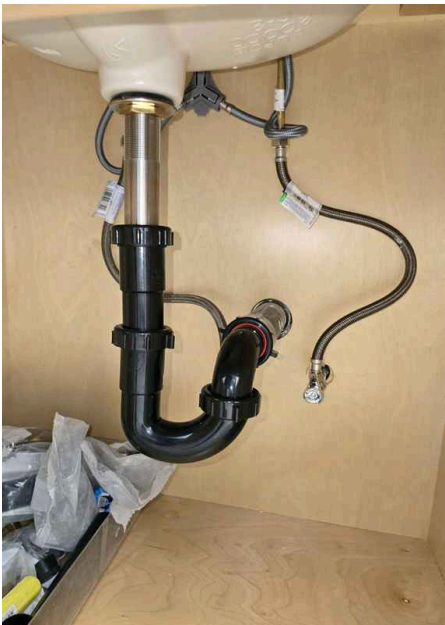
**Waste/Drain pipes: Plumbing drain pipes**

The sink(s) drains P-Trap(s) and drains are functional at time of inspection.

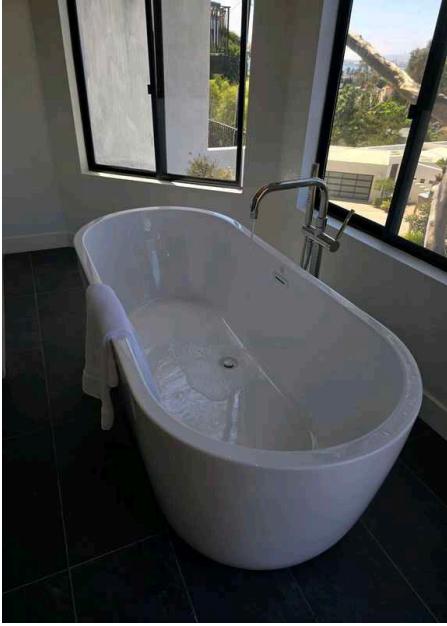
**Bath Tubs: Tub condition**

The bathroom tub is functional and in acceptable condition at time of inspection.

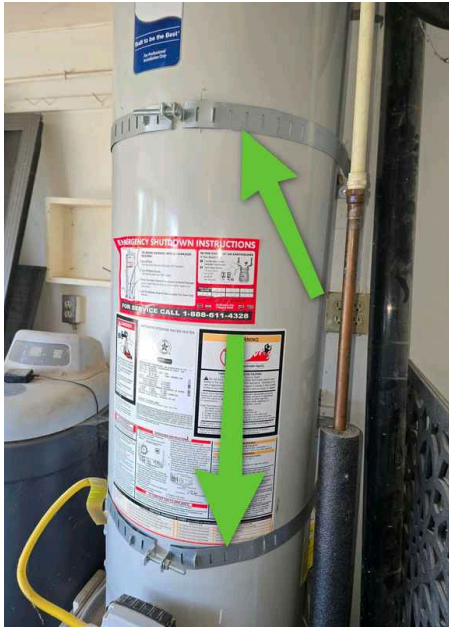
### Strapping: Seismic strapping

The water heater appears to have the approved / correct seismic strapping at the top and bottom 1/3 section of water heater tank

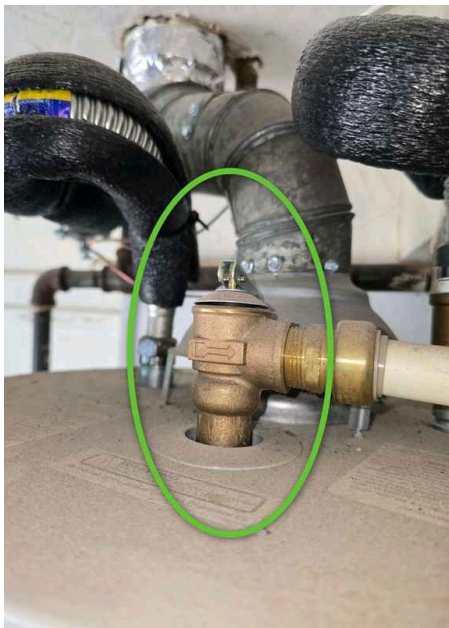
### TPRV: TPR Valve

The gas water heater temperature relieve valve is present and in satisfactory condition

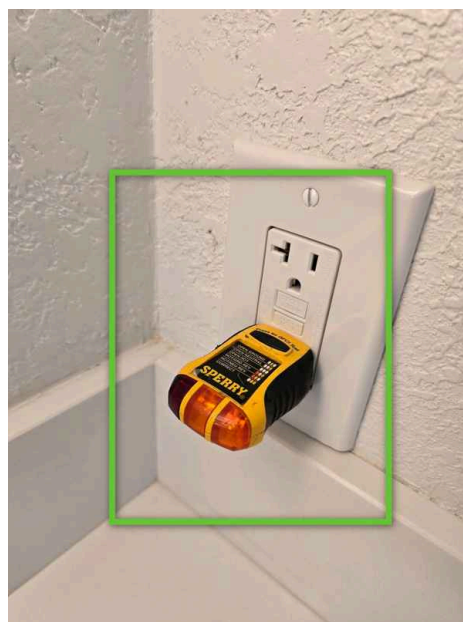
### GFCI: GFCI Condition

The GFCIs were noted functional at time of inspection.

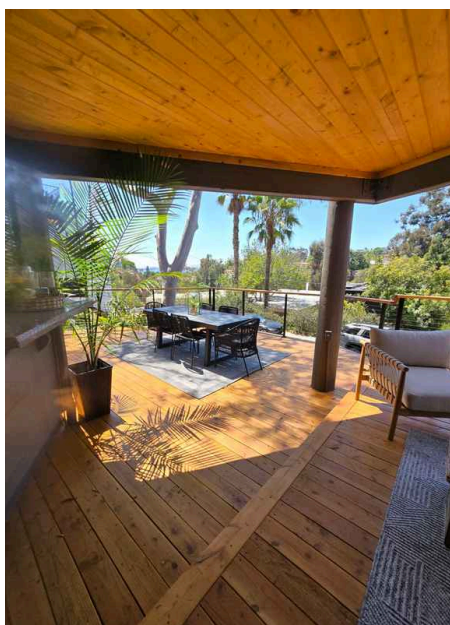
## Balcony/Deck: Balcony/deck condition

The balcony/deck Appear in satisfactory and functional condition with normal wear for its age, Appears to be sound structure.

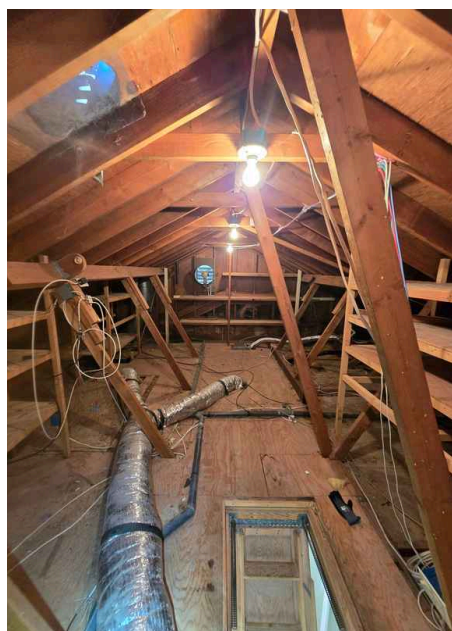
#### Structure: Stick built

The visible portions of the roof framing are in acceptable condition, and would conform to the standards of the year in which they were installed. However we recommend further evaluations by a licensed contractor as latent defects may exist.

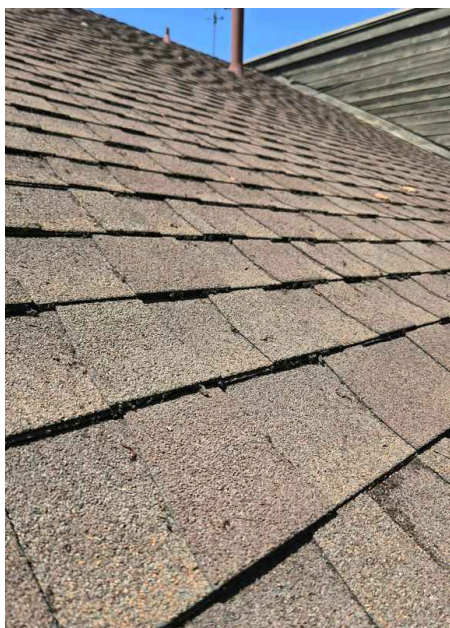
## Condition: Roof condition

The roof is in acceptable condition. But this is not a guarantee against leaks. For a guarantee, you would need to have a roofing company perform a water-test and issue a roof certification.

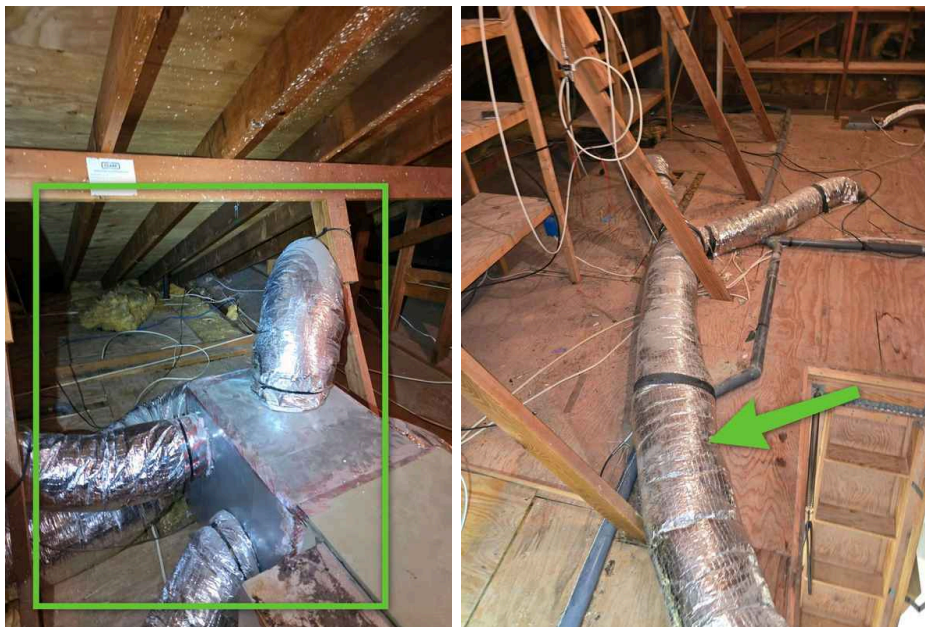
### Duct Work: Flex air ducts

The visible portion of the flexible air ducts are in acceptable condition.
